Site 14 Town Creek

Overview: The Town Creek salt marsh is located approximately 4 mi upstream from the mouth of the Merrimack River. There are approximately 350 ac of tidal wetlands upstream of the abandoned railroad embankment owned by MBTA. These wetlands are affected by a severe tidal restriction and predominately consist of large monotypic stands of *Phragmites*. Past studies of the tidal restriction have found the tidal range was reduced by approximately 3.5 ft upstream of the railroad embankment and an additional 1.5 ft upstream of Route 1A. Former salt marsh upstream (or east) of Route 1A is currently dominated by *Phragmites*, *Typha* or other palustrine wetlands. There is a number of low lying commercial properties along Route 1A which abut the marsh. Flow is conveyed via a 4 ft by 4 ft stone box culvert through the railroad embankment and a 36 in pipe under Route 1A. Several smaller culverts under Route 1A do not appear to provide any tidal exchange. There is a wooden flapper gate installed on the downstream end of the stone box culvert. When the railroad line was built in the mid-1800's, there was reportedly an 80-foot long trestle at Town Creek (J. Ray, MBTA pers. comm

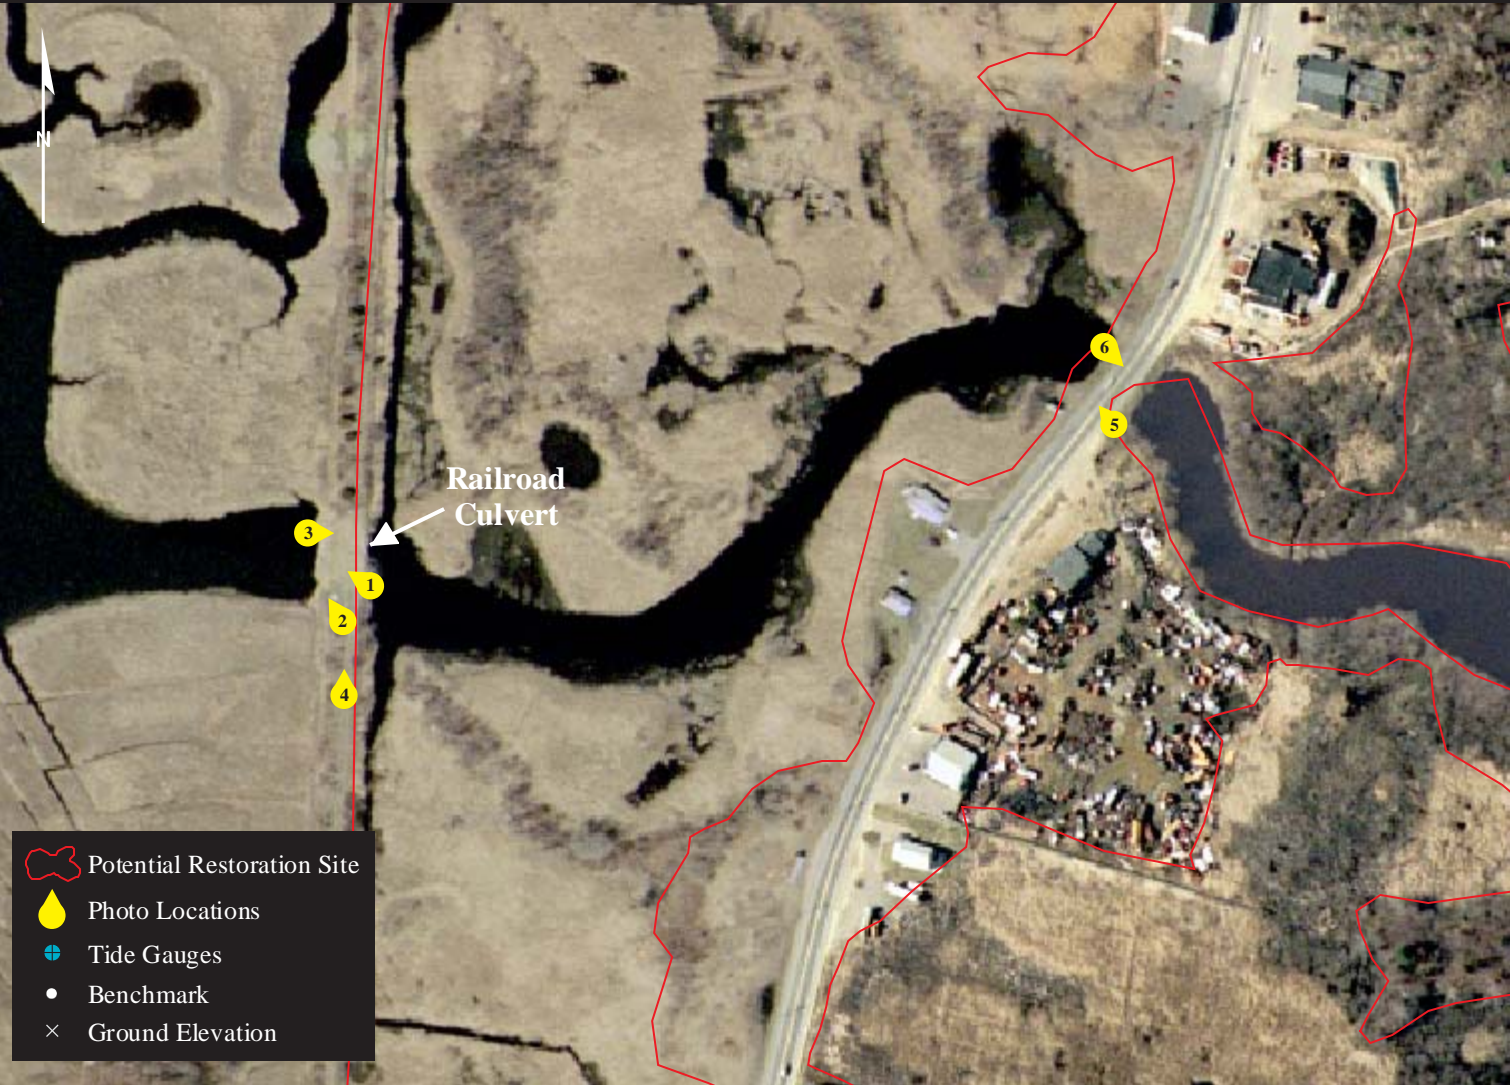
Railroad
Culvert

Structure conditions: Town Creek passes through the railroad embankment via a 4 ft by 4 ft stone culvert. The culvert is approximately 85 ft in length. The downstream toe of the embankment is armored with a low retaining wall of large cut stone. The downstream end of the culvert is fitted with a heavy wooded flapper gate which is approximately 5 ft square. The gate has been subject to damage and vandalism and has been replaced or repaired several times (D. Levesque, DPW Director, pers. comm.). At the time of inspection, the gate appeared too buoyant and remained in an open position allowing the incoming tide to pass freely through the box culvert. Even in a closed position, the gate appeared to be poorly fitted to the culvert opening allowing significant flows to pass through. More recently, a manhole cover was attached to the gate allowing it to function more effectively as a flapper gate.

During a severe coastal storm in late May of 2005, the embankment was overtopped and eroded away, exposing the stone culvert over its entire length. Prior to washing away, the elevation of the embankment was 9.8 ft (NGVD 29) (ACOE, 2002). The erosion exposed the northern abutment of a previous bridge structure which once existed at this location. The age of the current stone box is unknown. Reportedly, major repairs of the culvert were performed by MBTA in 1994 in response to an Enforcement Action taken by the Conservation Commission and the tide gate was replaced in 2003. Under the current condition, once tides overtop the stone retaining wall, water passes through the 15 to 20 ft wide by 8 ft deep cut in the embankment. The Town has received numerous complaints of flooding since the embankment damage.

Construction Logistics/Feasibility: A meeting was held with town officials, MBTA, CZM representatives and other state and federal stakeholders on September 8, 2005 to develop a course of action to remediate the resulting flooding and erosion problems, as well as to investigate the possibility of incorporating additional tidal exchange now or in the future. The Town's immediate goals are to get the breach in the rail bed repaired to protect against further flooding with the longer-term goal is to restore tidal flows at Town Creek without increasing flooding risks (J. Klima, Selectman, pers. comm.). The Town is in the process of negotiating a long-term lease of the abandoned line as a rail trail. However, the Town felt that MBTA was responsible for repair work. MBTA has taken the position that they are not responsible for the repairs but would assist the Town with some elements of the repair work. Opportunities to reduce the level of tidal restriction without impacted abutting properties (based on the Army Corps modeling efforts) were reviewed. Based on the immediate concerns of legal action and the additional time associated with securing restoration funding, the Town intends to repair the embankment in-kind as a maintenance activity exempt from Section 401 and 404 permit reviews. The work would consist of removing eroded material from the creek, repairing the culvert and headwalls and armoring the embankment slopes.
